# AZ Sportsmen For Wildlife Conservation GRANT COMPLETION REPORT

**Project Title:** Long Valley Meadow Restoration Phase II

**Organization:** Arizona Elk Society

## Long Valley Meadow Riparian Restoration Phase II

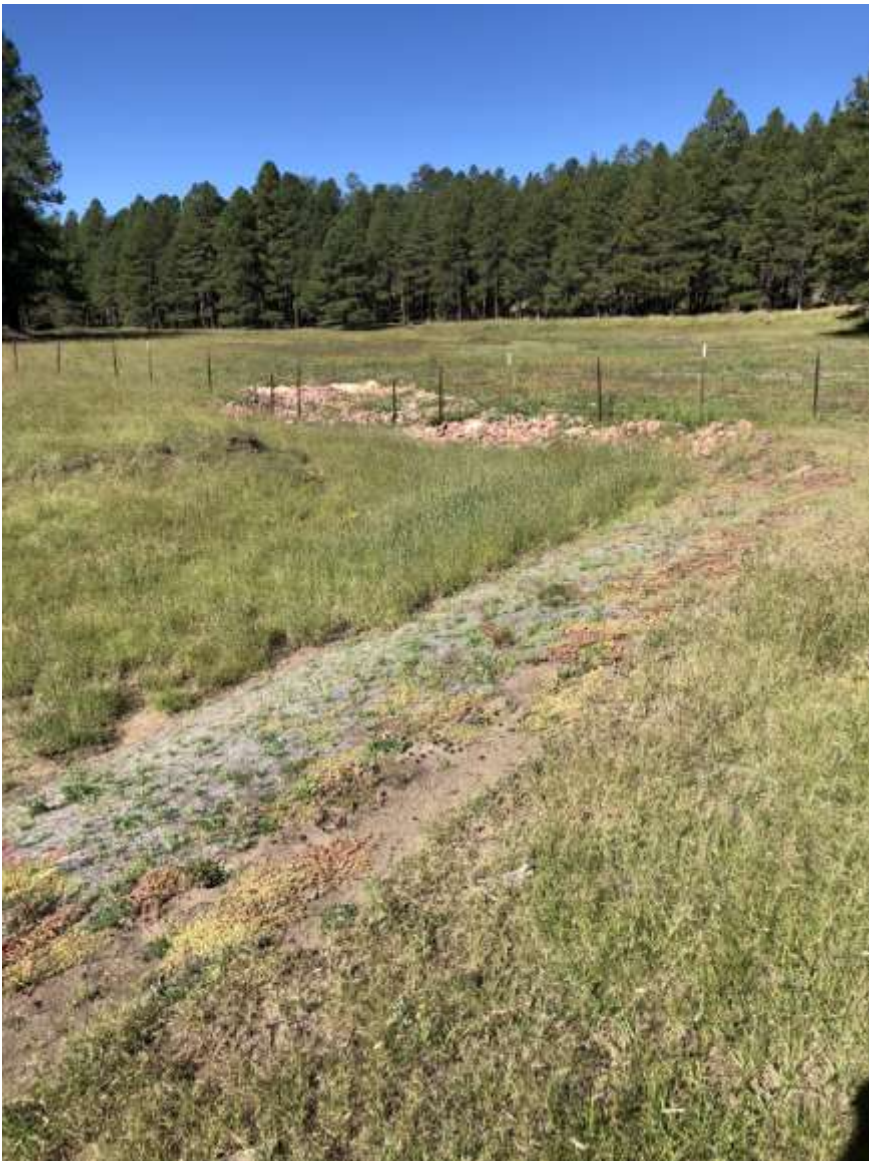
Long Valley Restoration Grasses

In the months after the majority of the work completion, the water flow has been significantly slowed by installed structures, ponds have formed and the distribution of water has been rerouted to the meadow, as more of a controlled sheet flow. We have seen no further erosion and the forage in the meadow has increased in density. Most of the bared areas that were seeded have grassed back in. Moisture retention in the soils has increased.

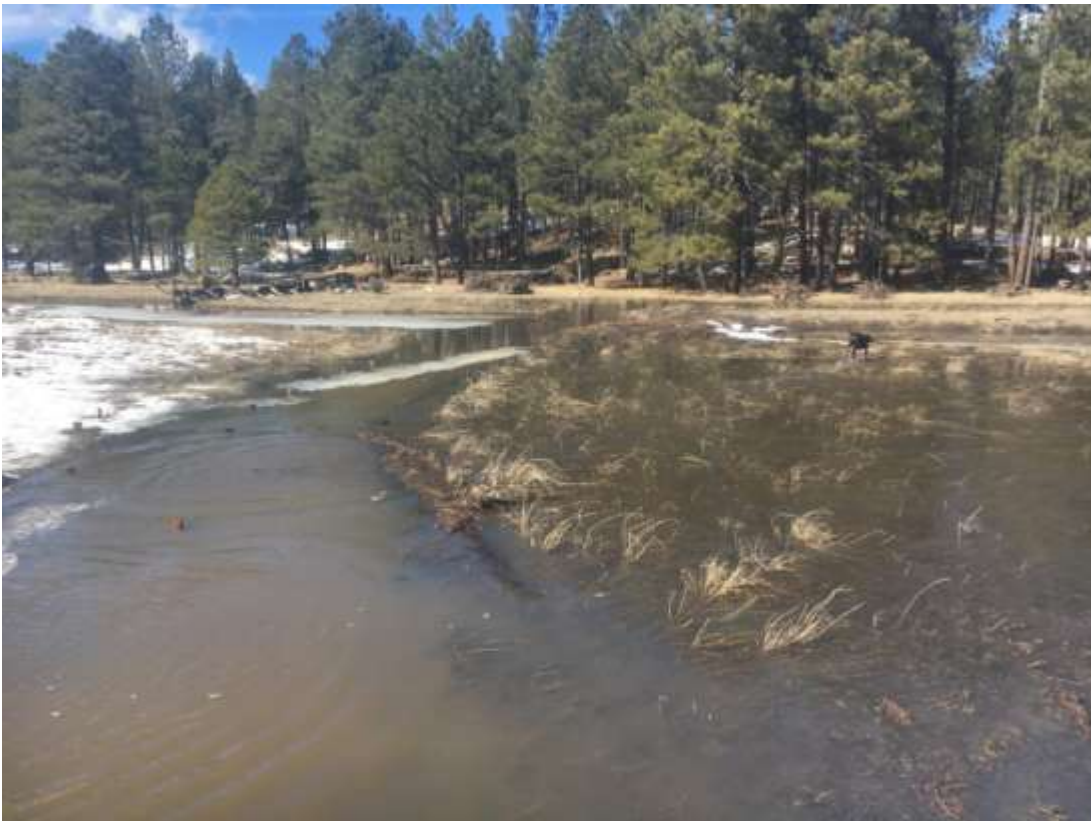
Highway Meadow Plug & Pond Feature

With our contractor all the earthwork including plug and pond construction in the incised channel, stock tank decommissioning which involved leveling the area for water distribution, digging and installing the log sills – basically sills designed to force the water to run further up the meadow sides and spill back into the meadow in a controlled release, grading and sloping of the channels to stop the erosion and the equipment mobilization/demobilization. All the rock and material were delivered and off loaded at this time.

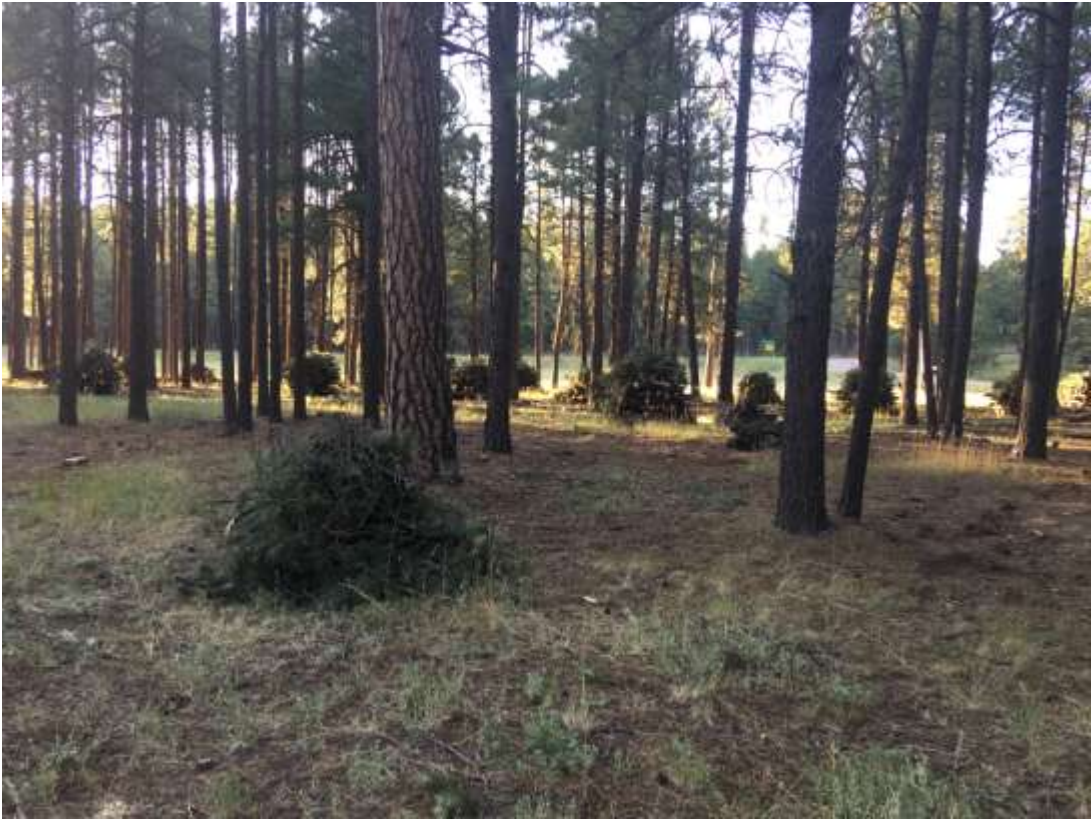
Sawyers After 2

At the same time, we brought in the AES sawyer crew to cut, limb and square up the necessary logs for the log sills, stacking all the left-over materials into burn piles to be burned by the Forest Service when conditions allow.

In July of 2019 we were granted permission to remove many more of the small diameter trees in the work project area. The Arizona Elk Society volunteer Sawyer crew brought 25 certified sawyers in and removed many more trees. These were in addition to the planned removal that had already been completed.

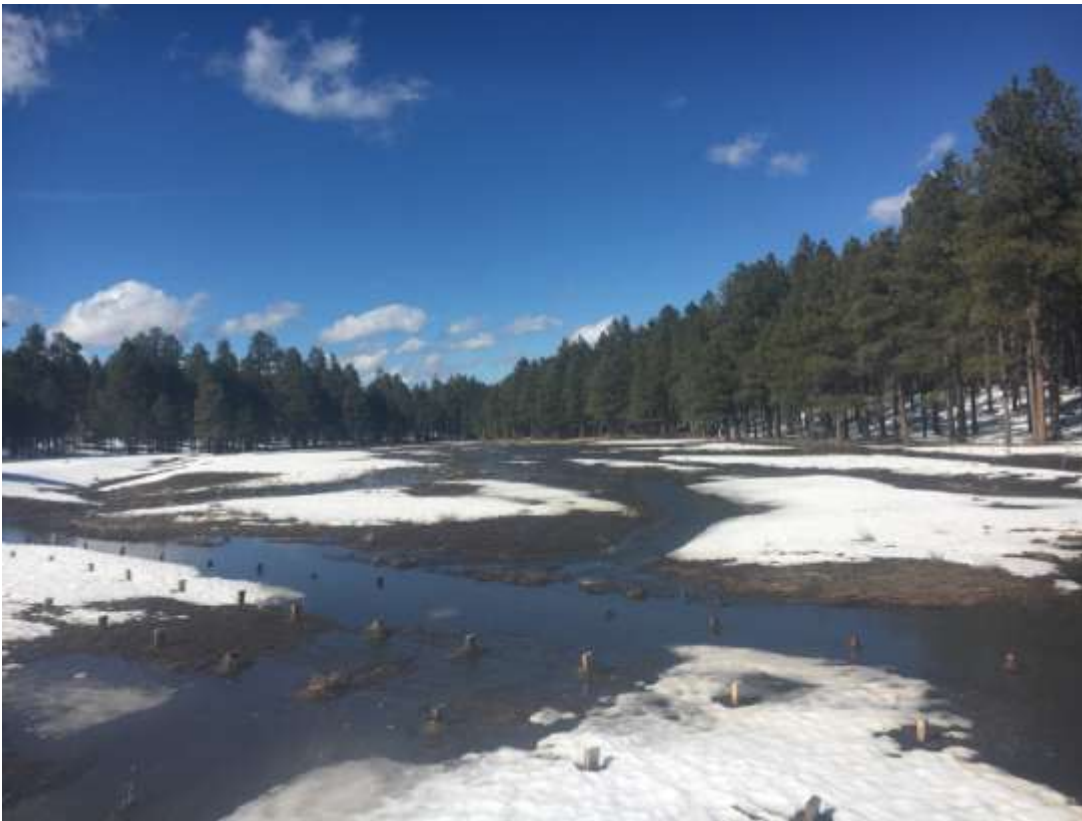
Spreader Doing Its Job

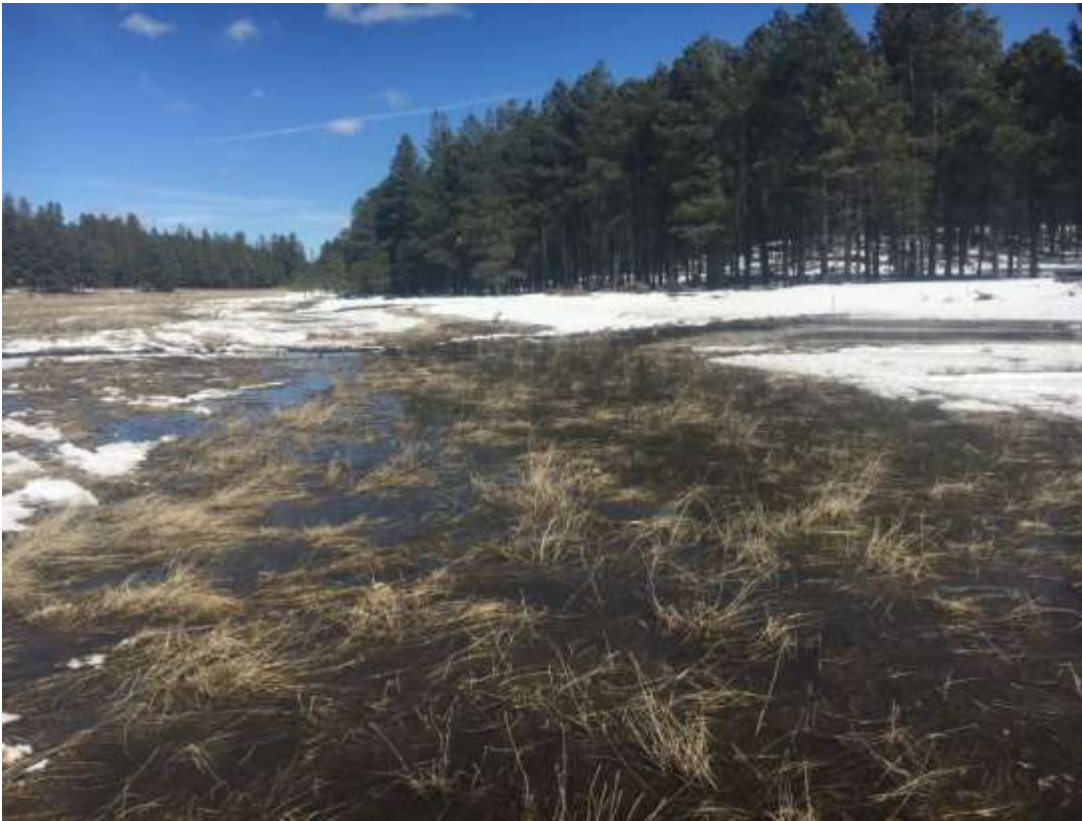
Water Accumulation on Meadow Below Spreader
